FORD MUSTANGS WITH CABLE CLUTCH LINKAGE

MUSTANG 5.0L AND 4.6L 1979-2004

FORD CARS AND TRUCKS

ALL FORD TRANSMISSIONS WITH ALUMINUM INPUT SHAFT RETAINER BEARING COLLAR

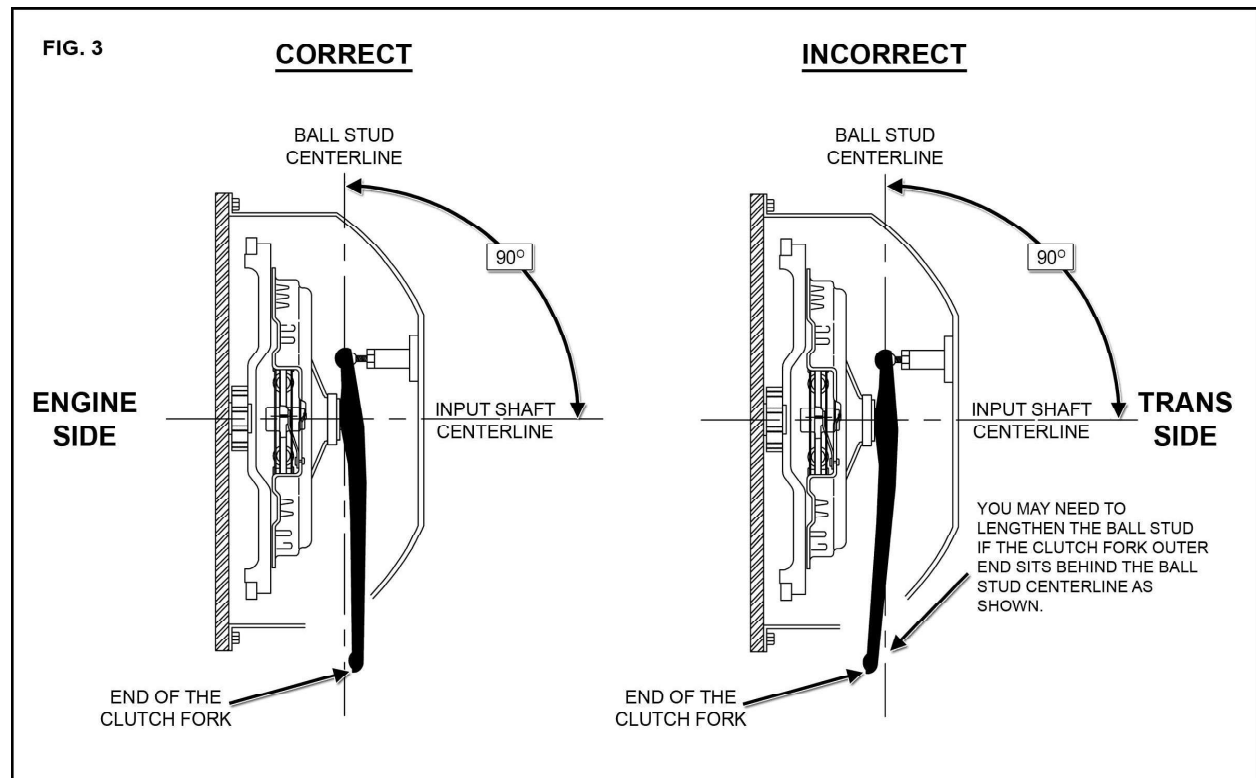
MECHANICAL CLUTCH LINKAGE GEOMETRY FINAL CHECK

Once the clutch assembly, release bearing, clutch fork and Bellhousing are bolted in place you can visually ensure the clutch fork ball stud is adjusted properly. Do not connect the remainder of the clutch linkage at this point. Move the clutch fork by hand until the release bearing contacts the clutch fingers. The outer end of the clutch fork should be pointed towards the transmission, behind the ball stud center as shown in FIG 3. If the outer end of the clutch fork is ahead of the ball stud centerline (pointing towards the engine), your clutch linkage is incorrect. Please re-visit the clutch fork pivot ball adjustment instructions or call the Centerforce Tech line at (928) 771-8422 for further assistance. Next, fully retract the release bearing away from the clutch fingers and visually check to insure that you have at least 1/4" clutch wear allowance gap between the release bearing and the clutch fingers. Once the geometry is correct, connect the remainder of the clutch linkage and then adjust to where the clutch engagement point is approximately half-way up the pedal travel. Small adjustments can be made to suit individual driving preferences. Throughout the service life of your clutch, be sure to periodically check the wear allowance gap and adjust as needed. Caution! If the clutch engagement point is at or near the top of your clutch pedal travel – your clutch may be pre-loaded (release bearing too close or touching the clutch fingers). Continued operation with the clutch in a pre-loaded condition will void the warranty and cause poor performance as well as significant damage.
