## SFM88MS SFM88MSB

SFM88MS/ SFM88MSB: 2018 Mustang GT Axle back

**Pypes Performance Exhaust**  
2705 Clemens Rd B103 Hatfield, PA 19440  
[www.pypesexhaust.com](http://www.pypesexhaust.com) 800-421-3890

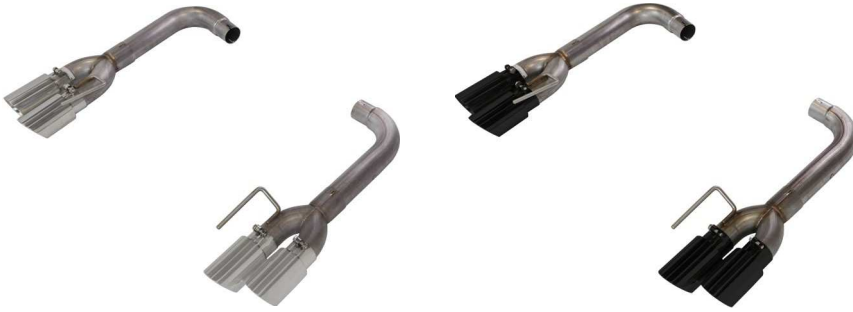
### BILL OF MATERIALS

| 1 | TFM88 Tail-pipes |
| 1 | YFM87 Y-Pipes |
| 4 | EVT57/578 Tips |
| 2 | HVC21 Clamps |
| 2 | HVC24 Clamps |

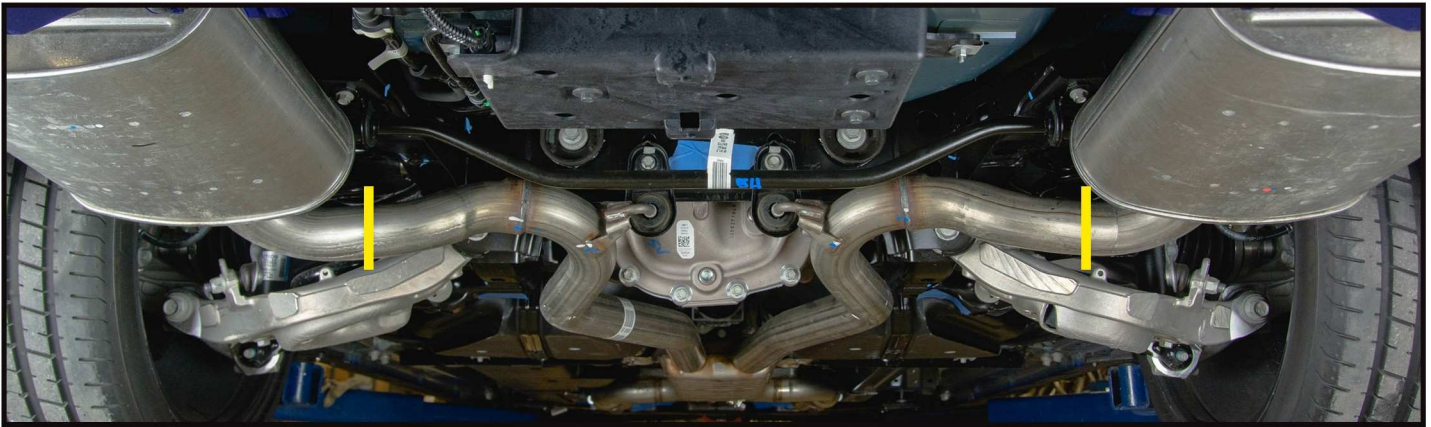
Cut the factory system close to the bend that leads to the muffler. This will give you the maximum amount of material for adjustments.

3. Begin your installation by cutting your factory system and removing the mufflers. It is critical to cut the factory system as shown above. This will leave you with the maximum amount of material to make adjustments to the system.
