CALIFORNIA
Pony Cars

COWL VENT REPAIR KIT

INSTRUCTION SHEET

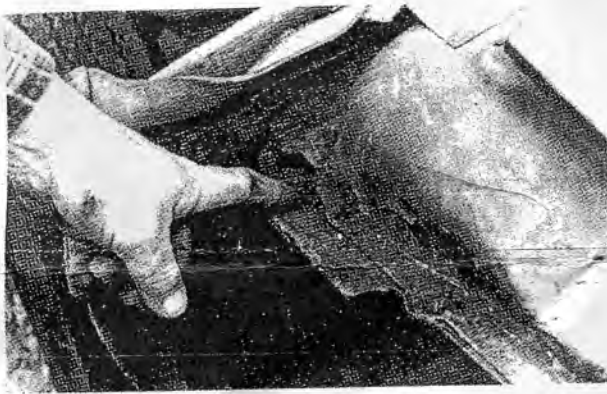
Check the source of cowl vent leakage. Run a garden hose over the cowl vent grille and check the flow of water at the fender bottoms. If flow is minimal at the bottom and excessive through the cowl vent opening under the dash, check the drain hole behind each fender for a stoppage. Factory sealant is many times the cause of plugged drain holes.

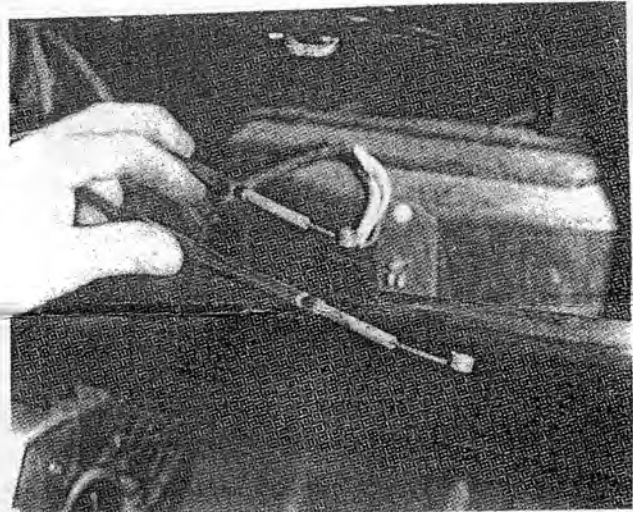
Disconnect the heater control cables and take note of where they were connected. Unplug the variable resistor (three-speed fan models only) on the front of the heater box.

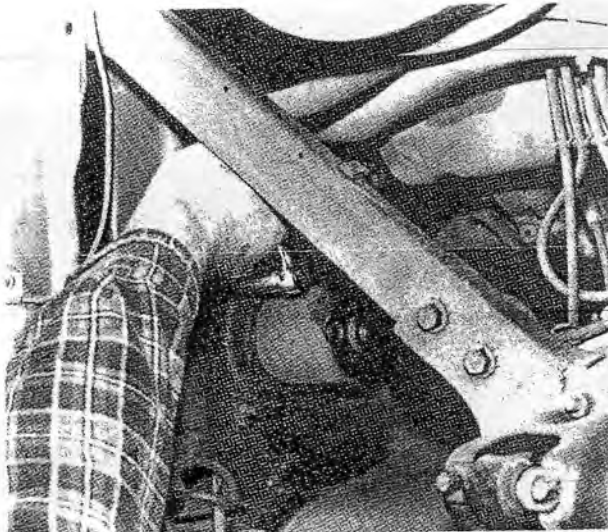
Unbolt the heater assembly from the firewall, unplug the fan motor, disconnect the heater hoses, and unfasten the heater box from the cowl vent attachment point.

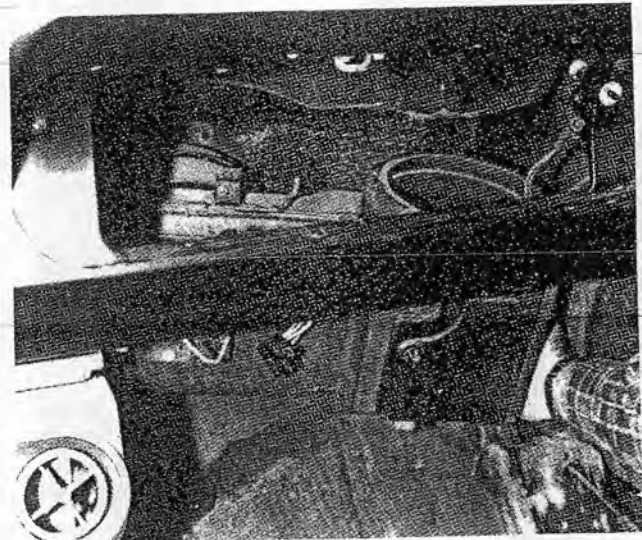
The heater assembly falls into your hands easily.

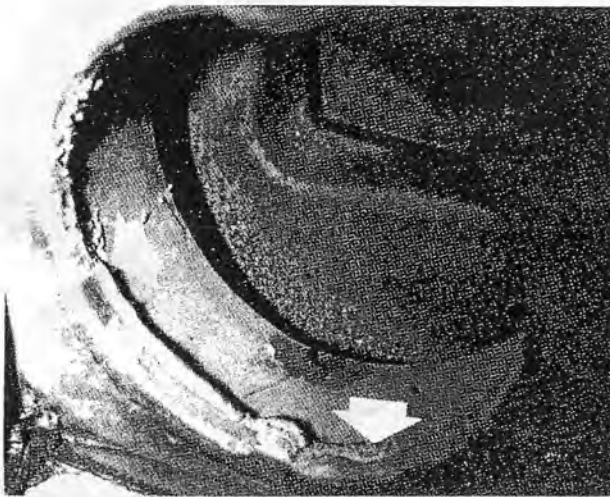
Not very impressive is it? The circular sheet metal dam is spot welded around its perimeter to the cowl belly. Aging body sealer allows water to leak past and onto your feet.

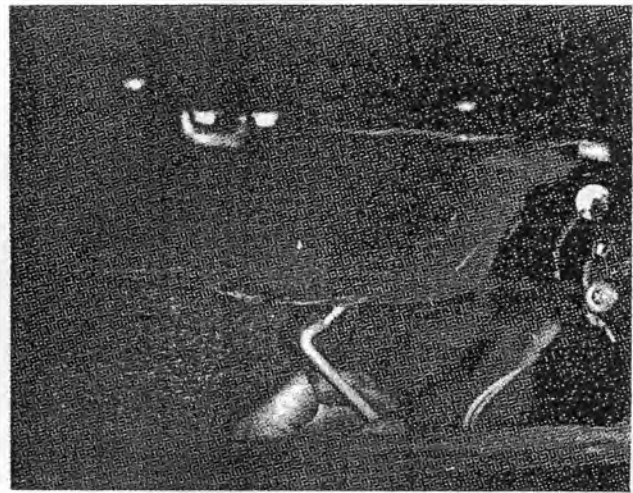
After a generous attack with a wire wheel, Steve applies a coat or two of rust inhibitor.

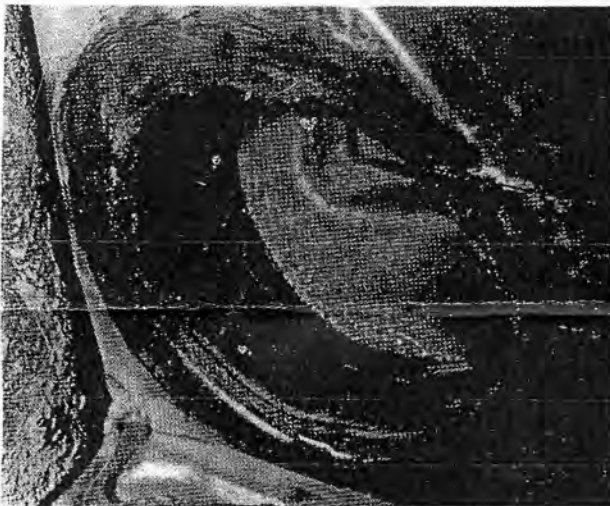
Notice the complete removal of all old body sealant at the gap.

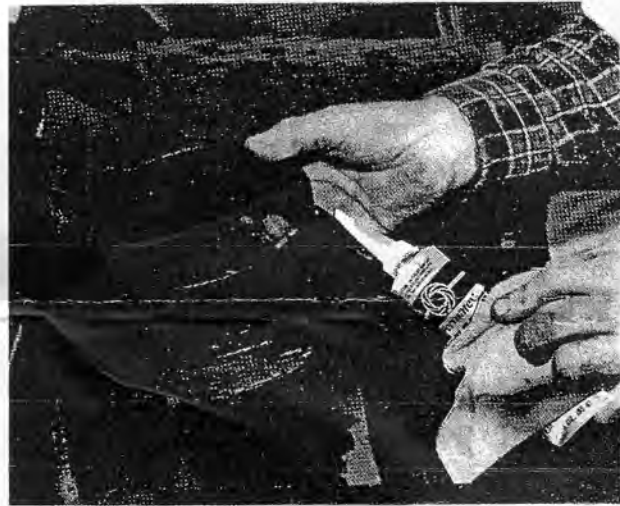
A thorough application of either Marine-Tex or windshield sealant, around the perimeter of the plastic hat assures you of a leak-tight seal. Did you remember to seal the gap between the circular dam and cowl vent lip?

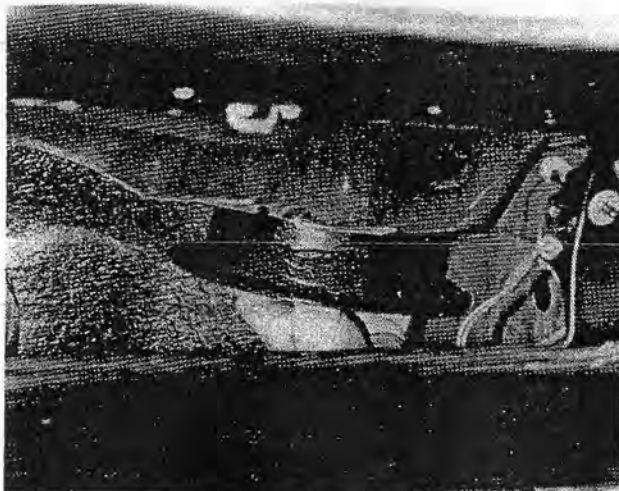
Insert the plastic hat up inside the cowl vent opening and find a way to keep it positioned until the sealer cures. Usually something wedged between the plastic hat and the floor or dash will keep it positioned.

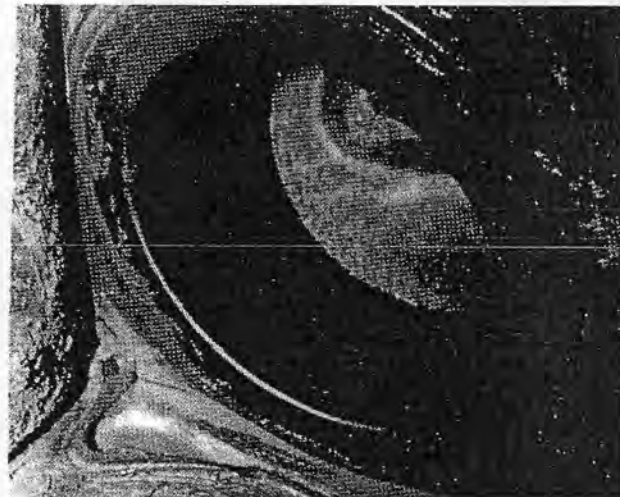
You'll have to admit, this sure beats Henry's design.
