**YOUR NEW CENTERFORCE® CLUTCH ASSEMBLY AND FLYWHEEL HAVE BEEN DESIGNED TO BE USED WITH LOCATING DOWEL PINS.**

## FORD MUSTANGS WITH CABLE CLUTCH LINKAGE

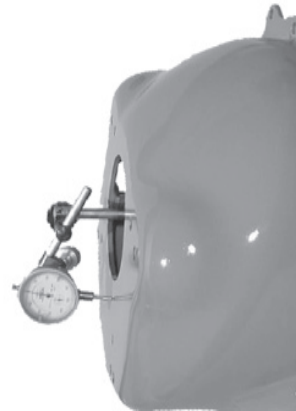
NEXT, THE BELLHOUSING FACE SHOULD BE CHECKED FOR PARALLELISM TO THE BACK OF THE BLOCK. INSTALL THE INDICATOR (AS SHOWN ABOVE). ROTATE THE CRANKSHAFT AND MARK DOWN THE READINGS (BE SURE TO PUSH THE CRANKSHAFT AGAINST THRUST BEARING FOR ACCURATE MEASUREMENT). THE MAXIMUM OUT OF PARALLELISM IS .002"
