FORD MUSTANGS WITH CABLE CLUTCH LINKAGE

To help achieve proper cable clutch linkage geometry, you will need to measure your flywheel deck height (distance from the flywheel crankshaft flange surface to the clutch friction surface) as shown in FIG 1. Aftermarket flywheel variances and/or flywheel resurfacing may have reduced your flywheel deck height from the Original Equipment (O.E.) flywheel measurement of 0.960”.

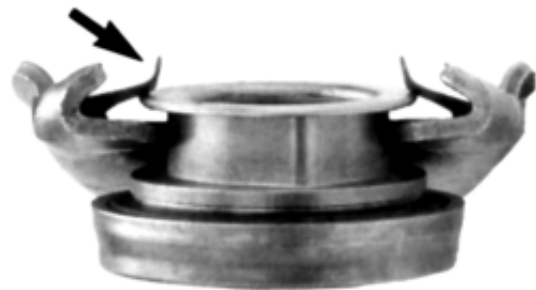
INCORRECT

NOTE: SELF ALIGNING TYPE THROWOUT BEARINGS WHEN REMOVED FROM THE BOX MAY APPEAR TO BE OFF CENTER, HOWEVER, THEY ARE NOT DEFECTIVE AND WILL PROPERLY ALIGN DURING USE.
